Assessment of 'Degradation of Aesthetics' (BUI #11) in the Detroit River Canadian Area of Concern

Prepared by Natalie Green & Chitra Gowda
for the DRCC's Monitoring and Research Work Group

2014

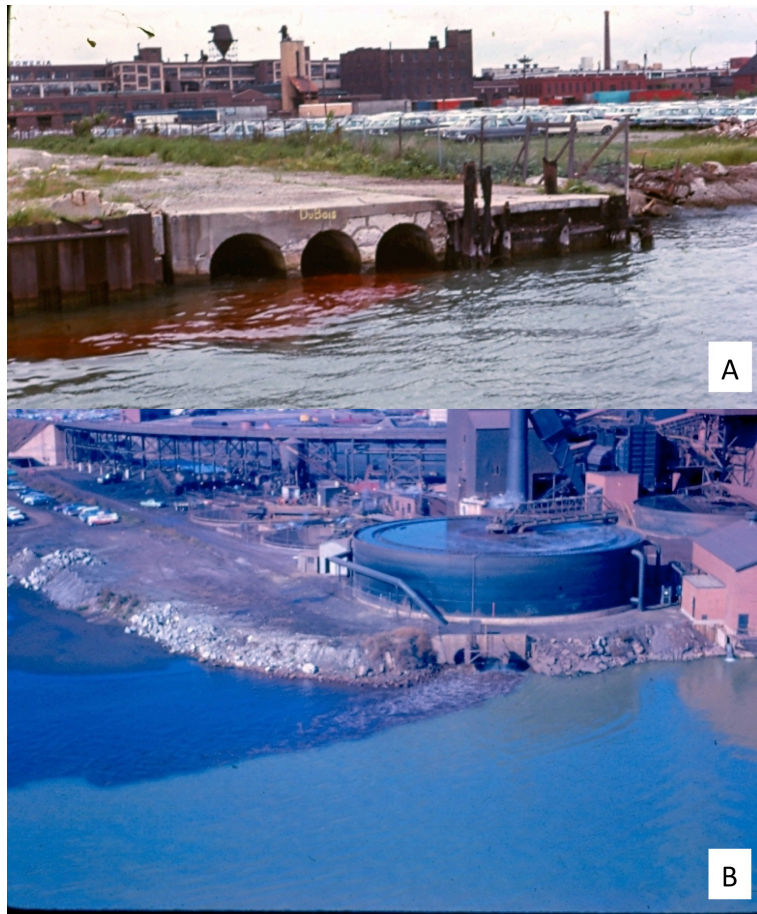
Figure 1. Aerial photographs of the Detroit River (U.S.) depicting unsightly discharges impacting the aesthetic condition of river water. (A) Blood from a nearby slaughterhouse outfall (ca. 1969); (B) Industrial discharge at McLouth Steel (ca. 1963).

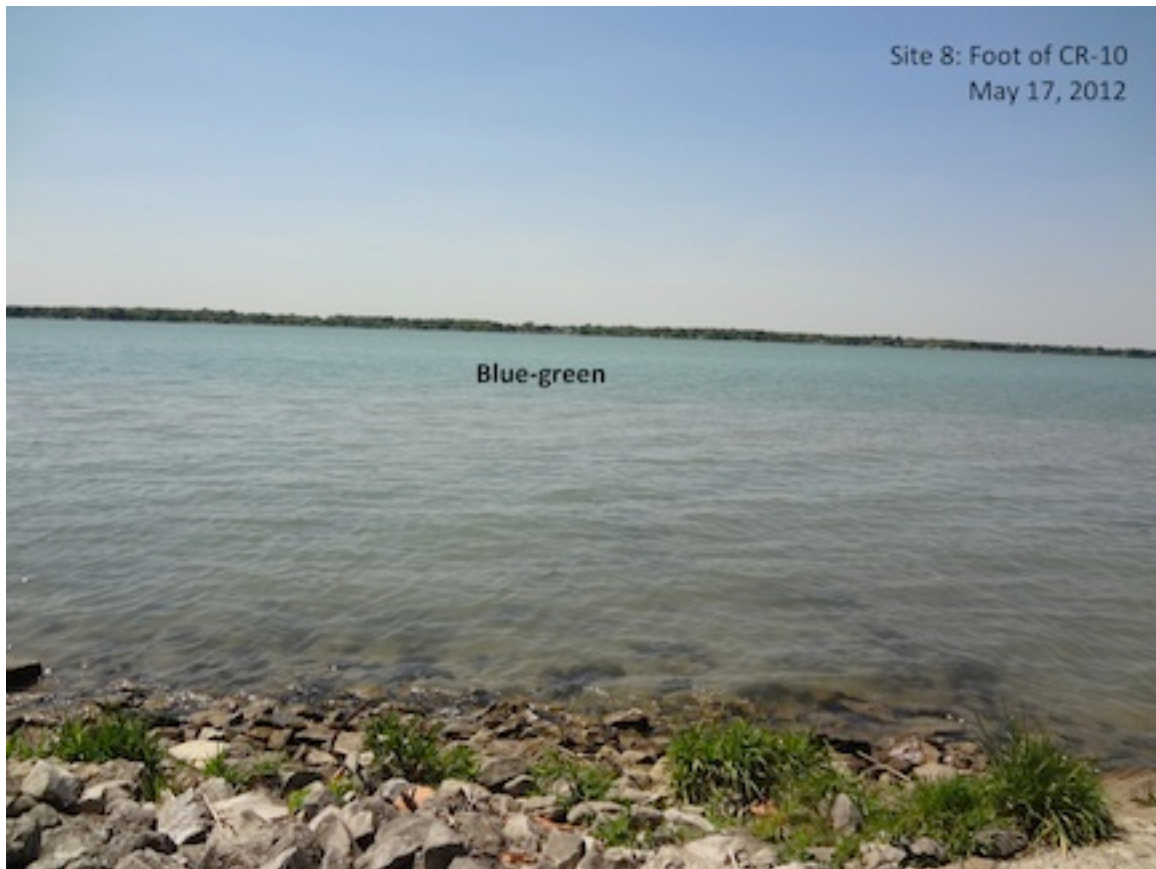
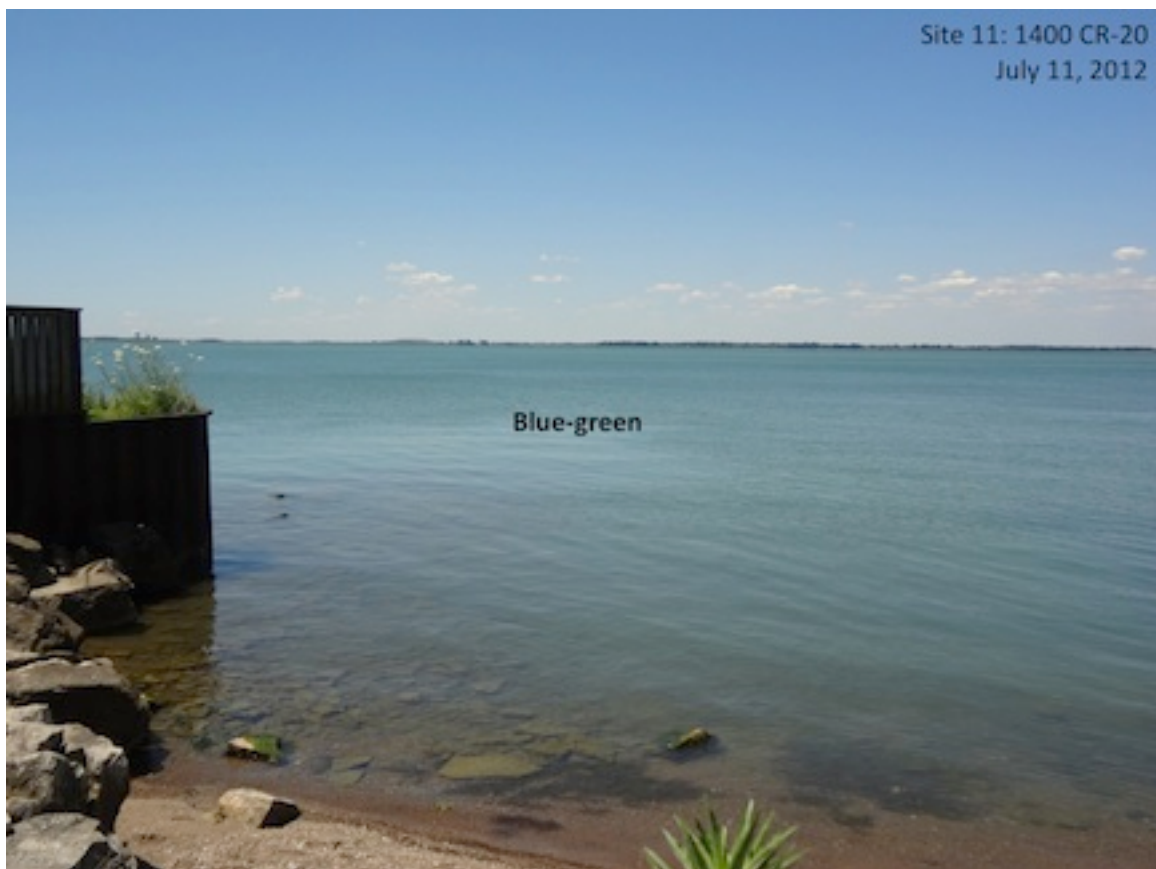
Figure 3. Sample photos showing the colour of the Detroit River (blue-green/teal) on a sunny day, clear day.

The colour indicator in the survey was very subjective and difficult to interpret without the use of a more rigorous scientific approach or equipment (e.g., colour meter). The colour of water was typically blue-grey (indicating some turbidity) and often grey or brown (more turbid) (Fig. 4). There was no discoloured water from anthropogenic sources (e.g., black oil or red blood) which was one of the reasons the BUI was listed as impaired in the 1991 Stage 1 RAP Report. Furthermore, it is important to note that while careful attention was made to ensure

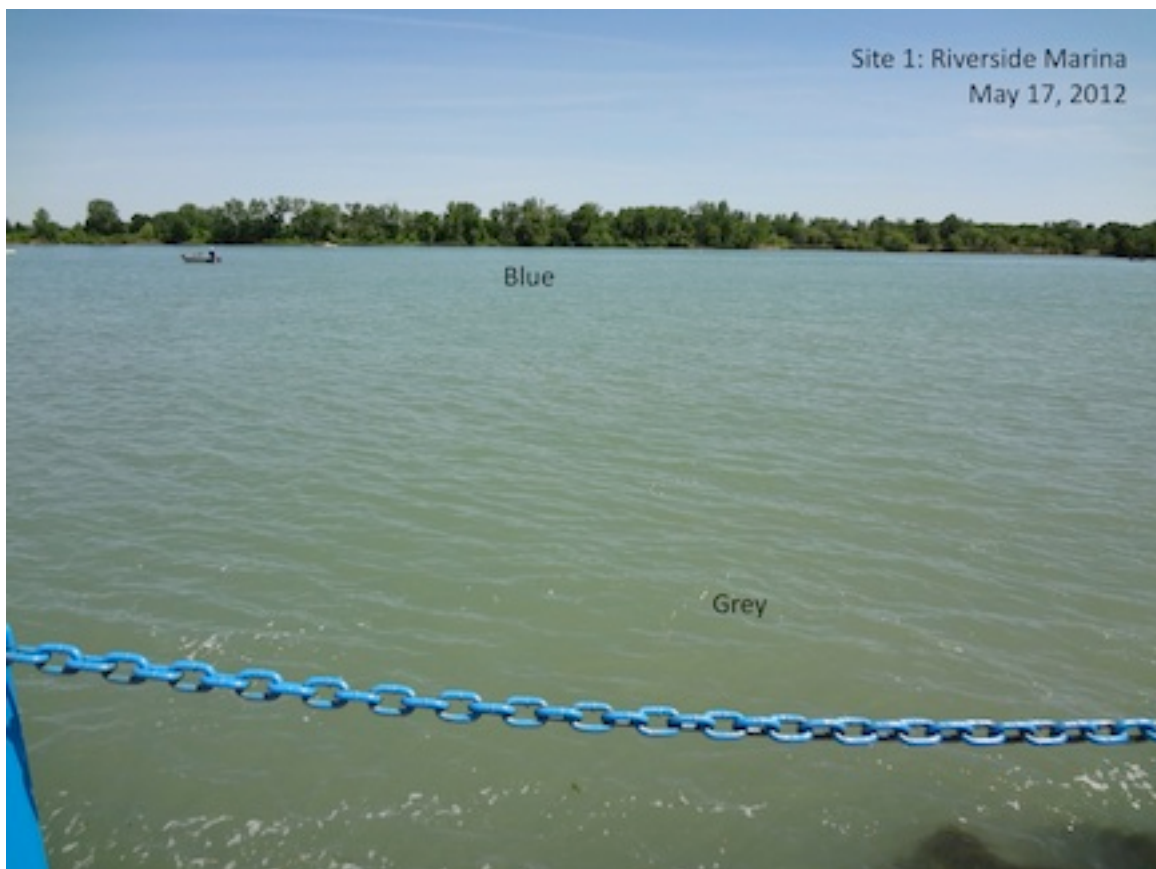
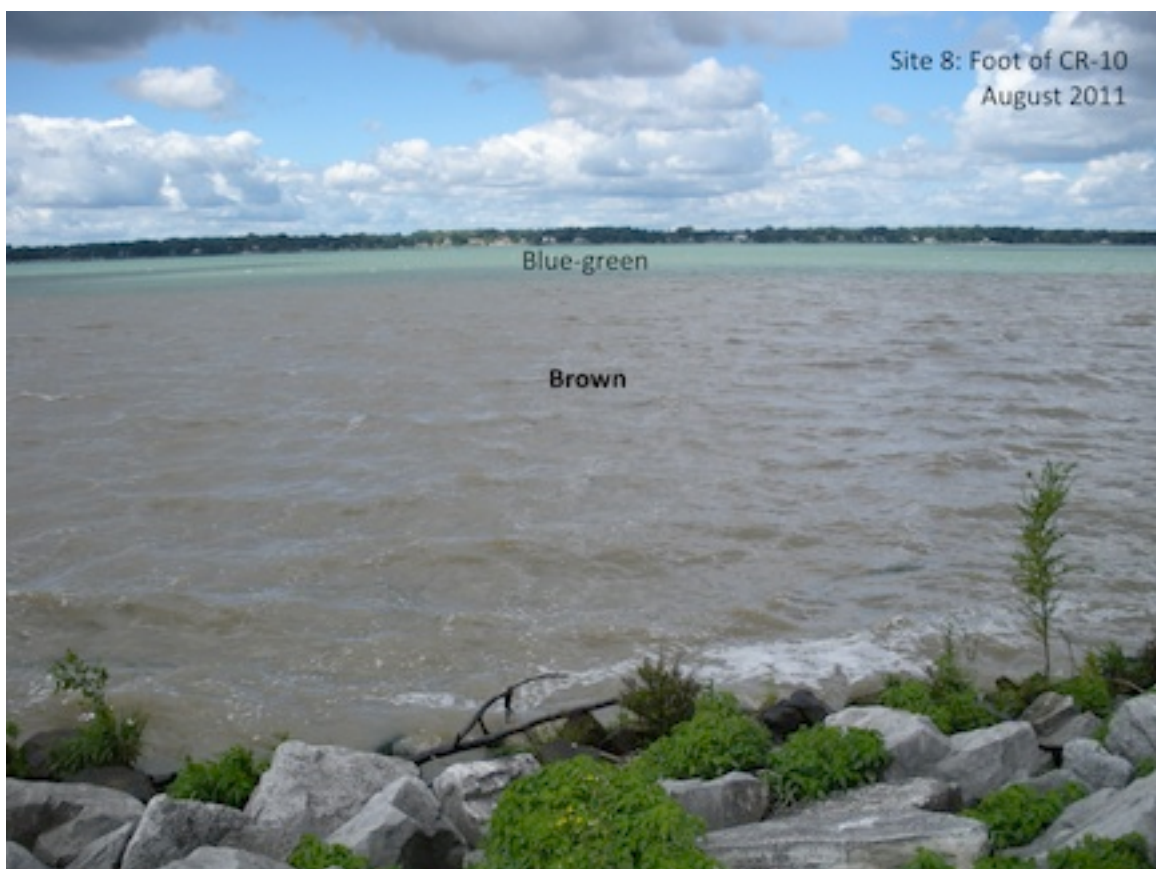
Figure 4. Example photos showing the differences in colour due to turbidity along the Canadian shoreline.

In order to discern between slightly turbid water and water that may indicate a more serious environmental problem, the results were divided into 4 different categories: clear (observer can easily see an object through water), turbid (observer’s view of object underwater is difficult but still possible), opaque (observer cannot see object through the water), and turbid + brown (indicating a more serious turbidity problem) (Table 4). Our results indicate that the Detroit River showed signs of turbidity (cloudy) during 76.3% of all sampling events while water was only clear 9% of the time and opaque (indicating severe turbidity) during 14.1% of the sampling events.

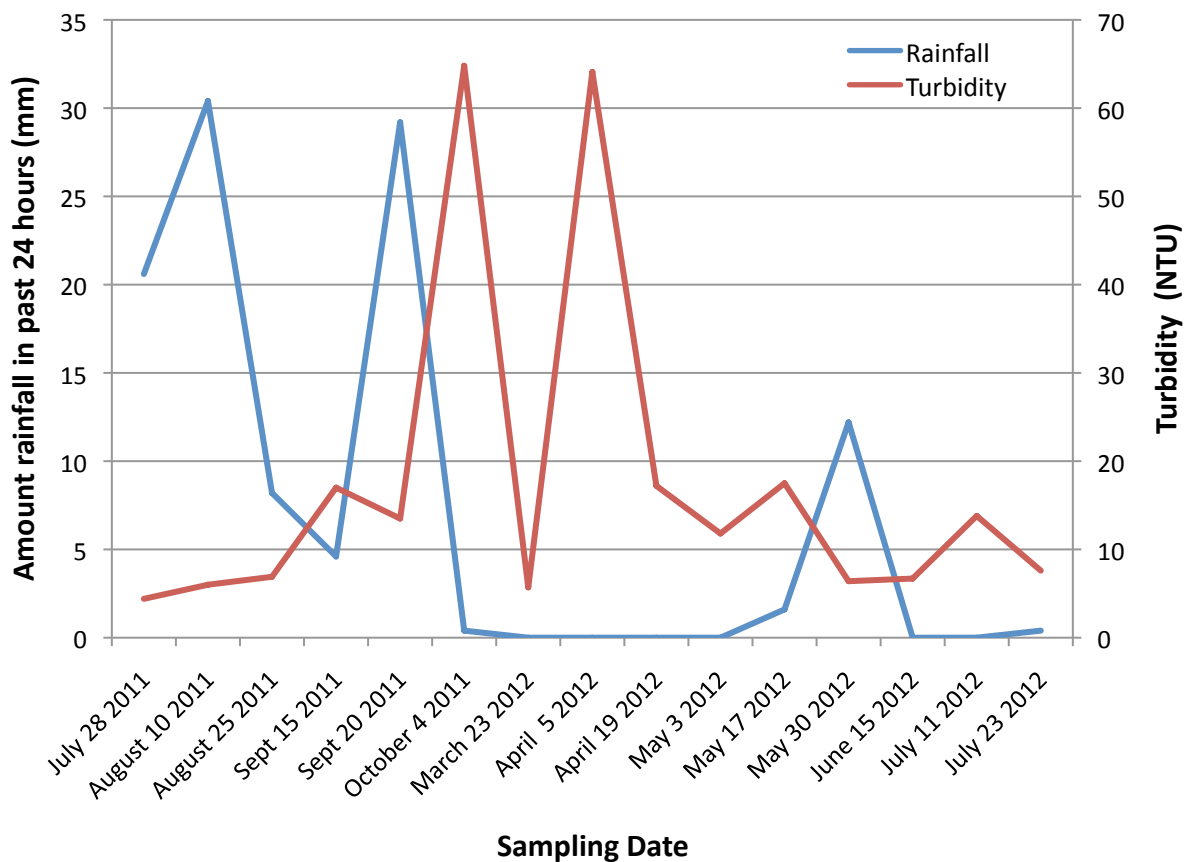
Figure 5. The amount of rainfall in past 24 hours of sampling date (from Weather Network) and turbidity values recorded on each sampling date at the A.H. Weeks Drinking Water Treatment Plant intake.

It is generally believed that turbidity is worse during rain events (due to runoff) or strong winds because this is when sediments are stirred up. Therefore, we examined turbidity against rainfall amounts and wind speed. There was no consistent relationship between high turbidity units and weather conditions (Fig. 5: precipitation and Fig. 6: wind speed) during our sampling events. The results suggest that the persistent turbidity observed in the Detroit River is not likely due to local runoff or weather conditions but probably somewhere outside of the A

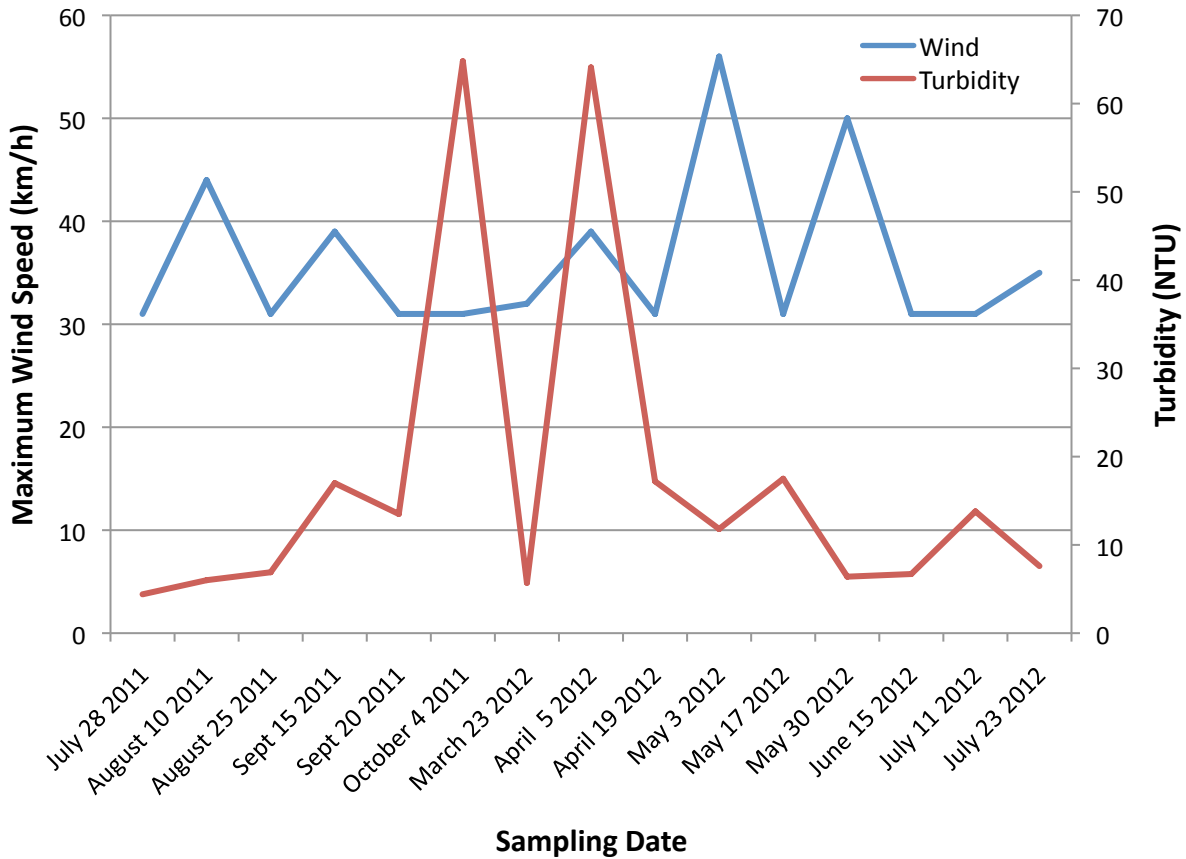
Figure 6. Maximum wind speed recorded at the Windsor Airport (from Weather Network) and turbidity values recorded on each sampling date at the A.H. Weeks Drinking Water Treatment Plant intake.

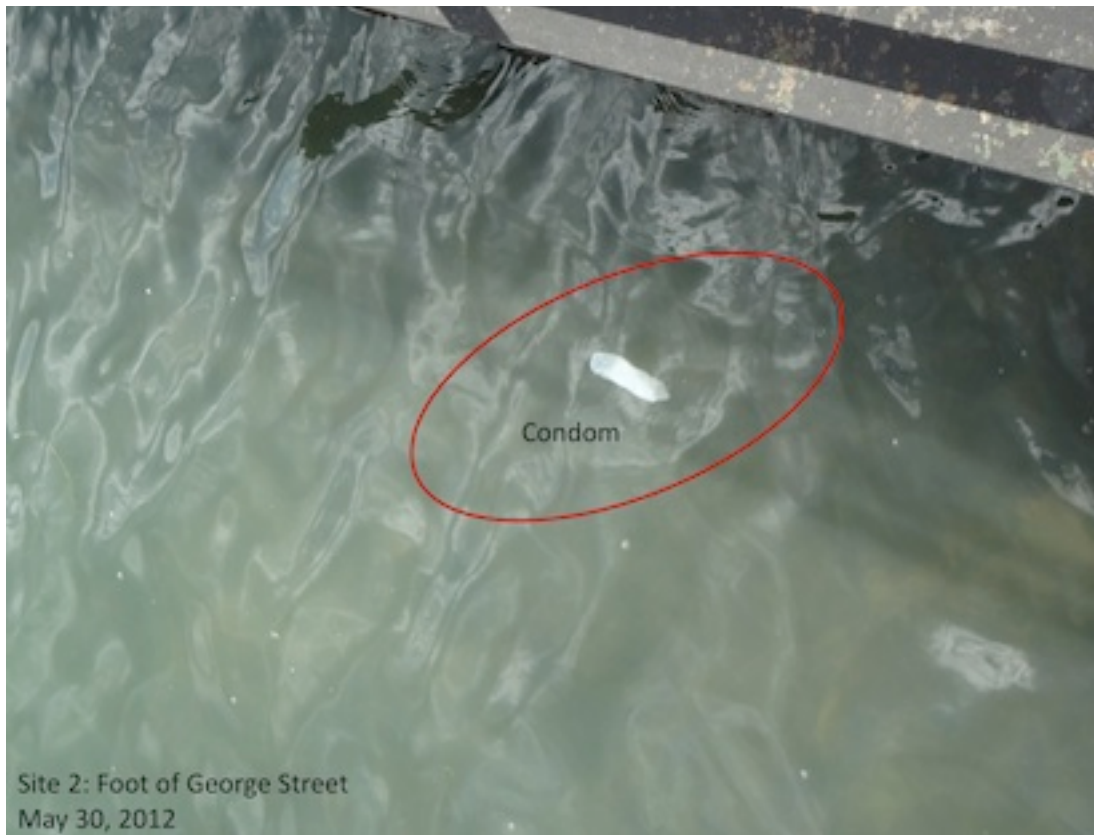
Very few occurrences of trash (one cup, one milk carton, one condom, and cigarette butts) (Fig. 7) were noted 4 times during the survey, representing only 2.6% of all sampling events (Table 6). Natural debris such as dead mayflies, flower petals, sticks and leaves (Fig. 8) were much more prevalent—noted during 43.6% of all site visits—but are not indicative of anthropogenic pollution. For example, mayflies are aquatic insects that are indicative of good water quality (as they are not tolerant of water or sediment pollution) and are an important food source for fish. They have a short adult life cycle; after emerging from the water, adults generally live for up to 3 days and they die shortly after laying their eggs in the water. It is very common to see many dead mayflies near healthy waterbodies in late June-early July when they were recorded in this survey.

| SITE | n | # of times noted | COMMENTS |
|---|---|---|--|
| George Avenue | 15 | 1 | One condom (Fig. 7); after a rain event (12.2 mm) |

Figure 7. Photo of debris found once during survey after a heavy rainfall.

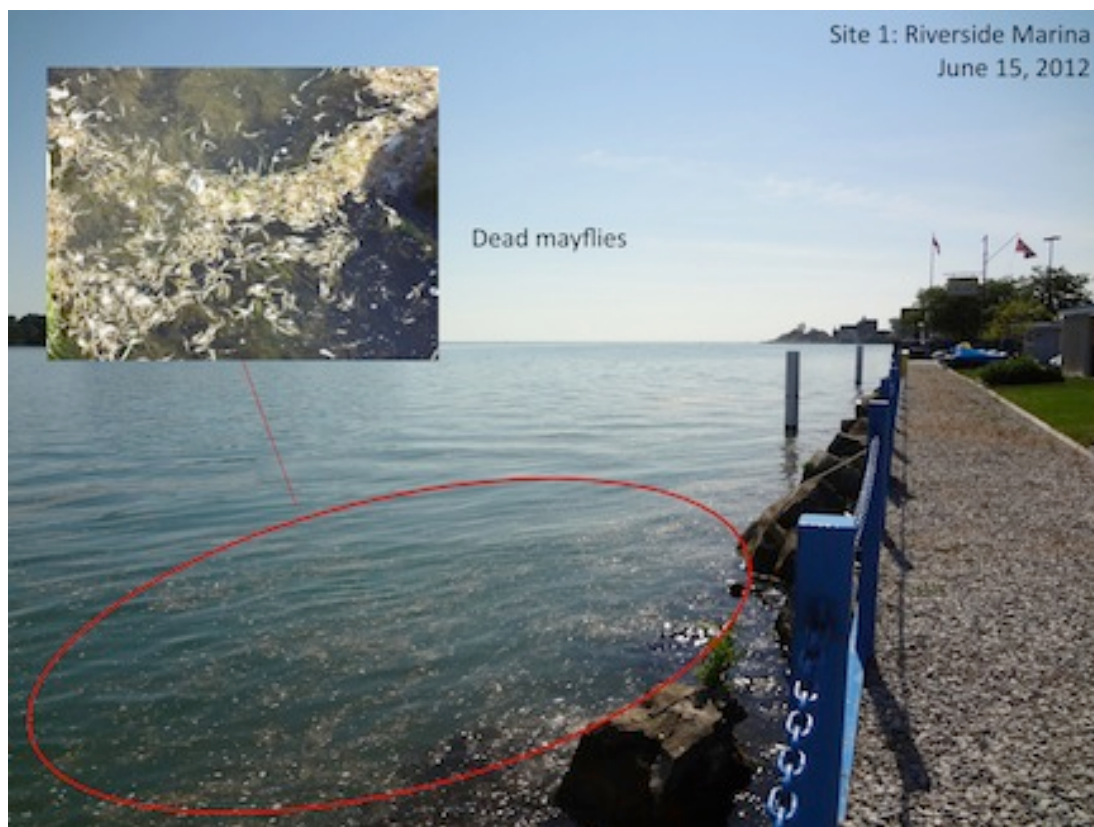
Figure 8. Example photo showing large amounts of dead mayflies along the shoreline at Riverside Marina (Site 1). These occurrences are seasonal.

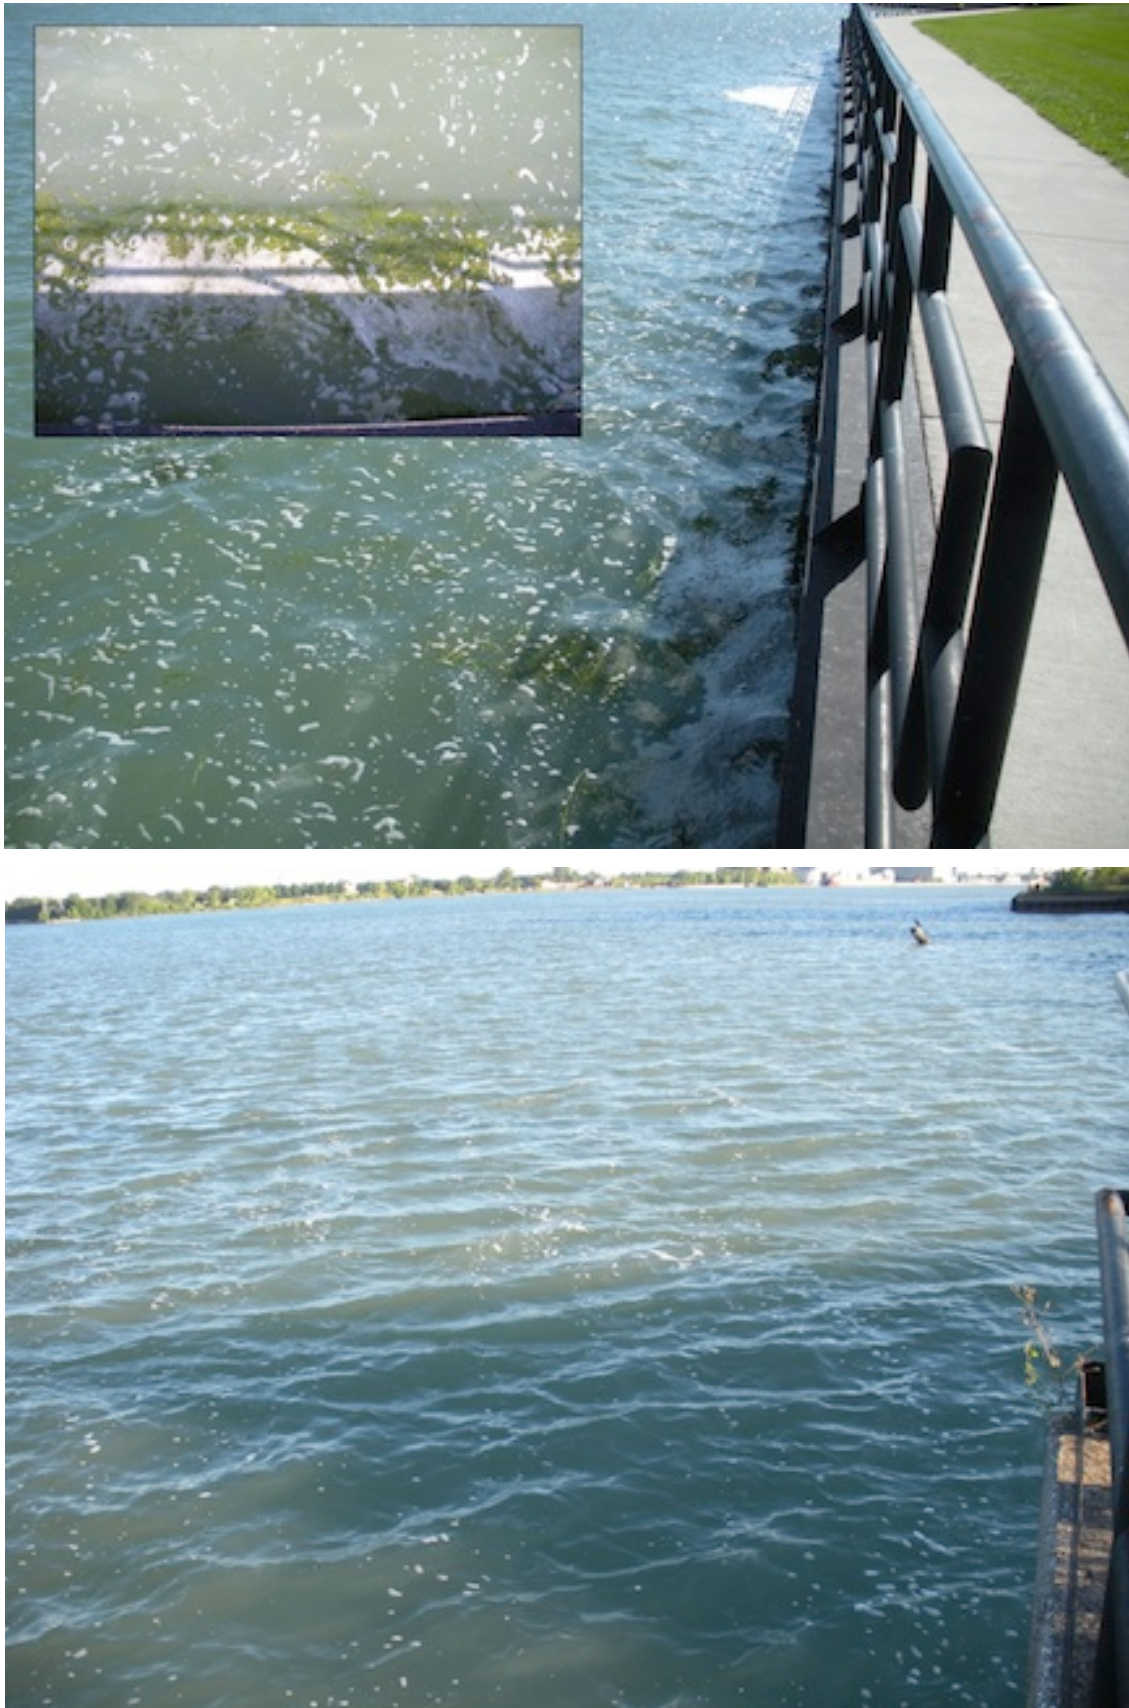
When present, the colour of the foam in Detroit River water was recorded. Foam visible in the Detroit River was usually white and sometimes brown (Fig. 9); no perfume or soap smells were ever noted and usually paired with floating vegetation. Our results suggest that foam in the Detroit River is naturally-occurring and most likely due to decaying vegetation or fine sediments in the water.

Figure 9. Example photographs showing different types of foam occurrences on the Detroit River. Top: foam collecting along the shoreline with decaying vegetation. Bottom: sparse foam present throughout the nearshore area.
